Building Inspection Report

1842 Somewhere Drive

Inspection Date:
10/01/2005

Report Number:
78905

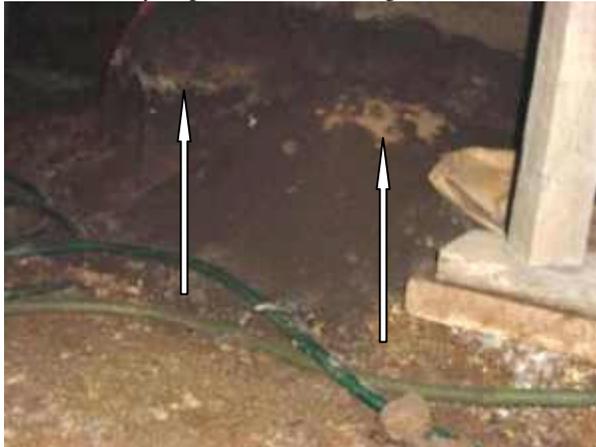
- **Monitor:** There is evidence of past water in the crawl space. Wet crawl spaces risk building damage from rot and insects and can cause interior mold or mildew. This condition may vary seasonally and/or with precipitation intensity. Roof and lot drainage repairs or improvements should be addressed as a first step to controlling water in the crawl space (see "Exterior"). This condition should then be monitored to determine if additional, potentially costly measures are necessary to protect the building interior from water and moisture damage.

Moisture Residue in Crawl Space

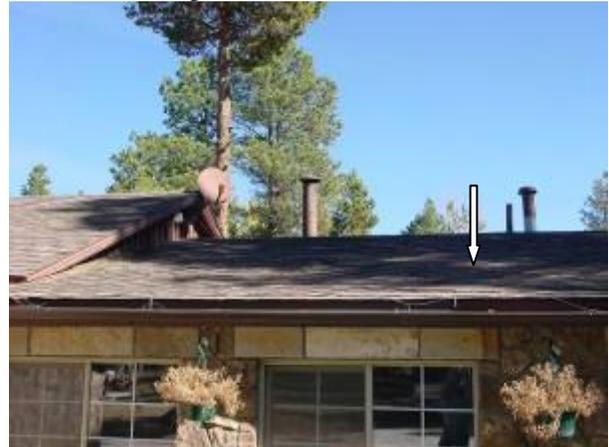
Sag in Low Pitched Roof

- **Monitor:** The rafters of the roof structure show evidence of minor sagging at the rear of the house. Strengthening the roof structure would resist further movement. This improvement is not priority unless the roof is likely to be subjected to heavy loads such as from snow or additional layers of roofing material whose weight could cause further damage. Additional support can often be added easily.

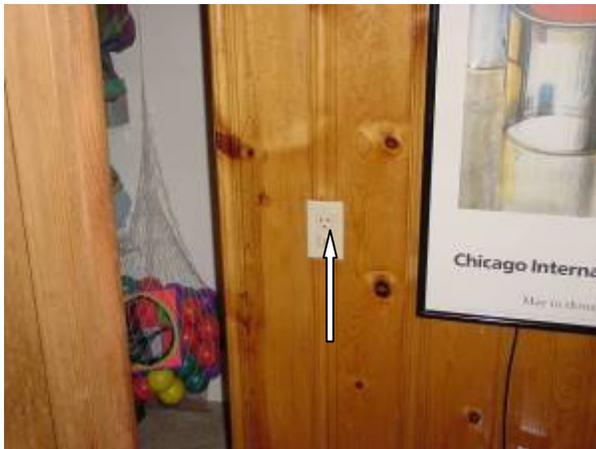
- **Repair:** It appears that one circuit of the branch wiring in the North West corner of the home is not properly grounded. This could cause damage to computer equipment as well as other solid state circuitry. Ungrounded 3-prong outlets should be repaired. In some cases a ground wire may be present in the electrical box and simply needs to be connected.

The outlets on this circuit are not properly grounded

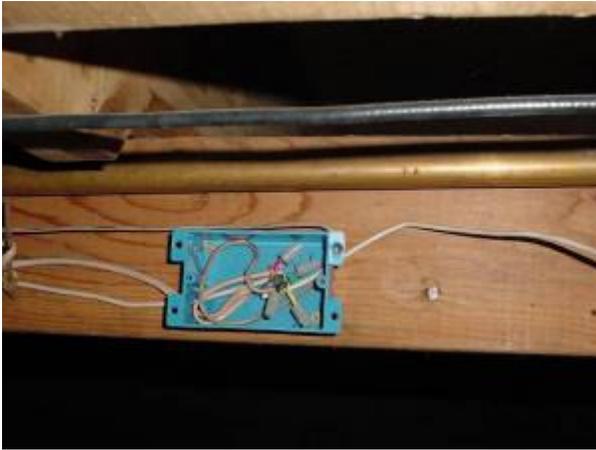
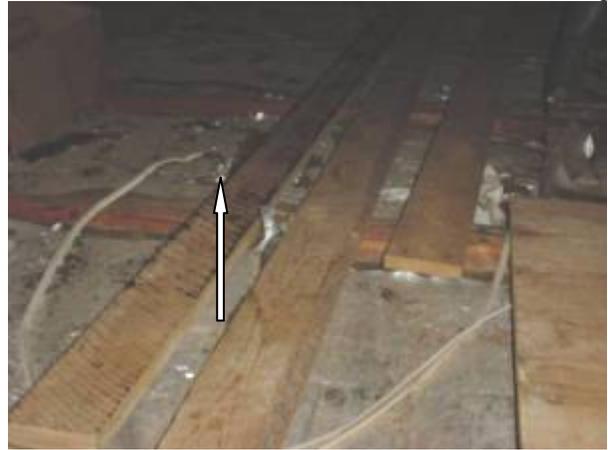
- **Repair:** Junction boxes in the Crawl Space and the Attic should be fitted with cover plates, to reduce fire hazard and protect the wire connections.

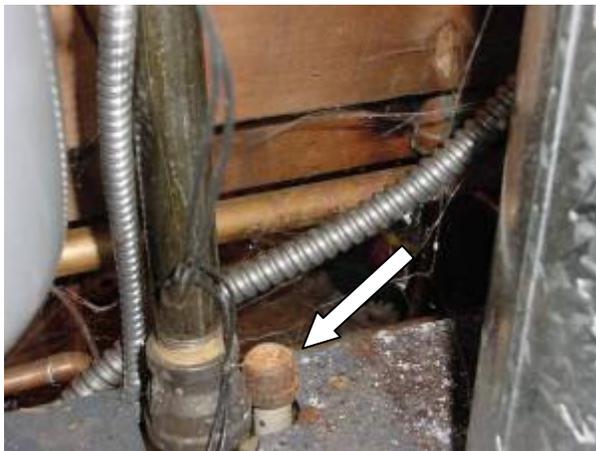
Missing pressure relief valve on boiler

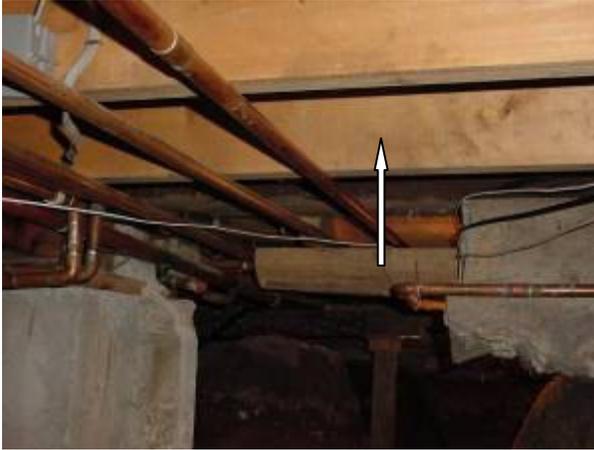
- **Improve:** It would be wise to insulate the “rim joist” cavities around the perimeter of the crawl space.
- **Improve:** Insulation improvements to the floor above the crawl space may be desirable, depending on the anticipated term of ownership.
- **Improve:** It would be advisable to install a moisture barrier on the crawl space floor.
- **Repair:** Evidence of mildew was observed in the crawl space. This is suspected to be related to improper ventilation. One (1) square foot of free vent area should be provided for every five hundred (500) square feet of crawl space. Proper ventilation will help to control humidity and reduce the potential for rot. Crawl spaces can be vented to the building interior or exterior, depending on the configuration of the crawl space.

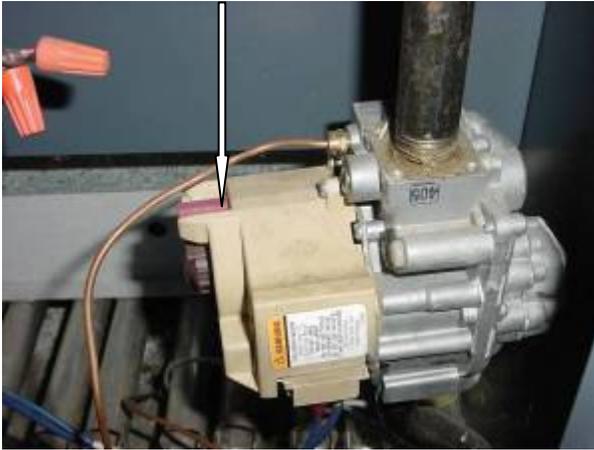
- **Repair, Safety Issue:** *A gas leak was detected on the pilot valve of the boiler. This is a serious safety concern. It is recommended that the gas utility be engaged immediately. The current occupants of the home should be notified.*

Leak at pilot button

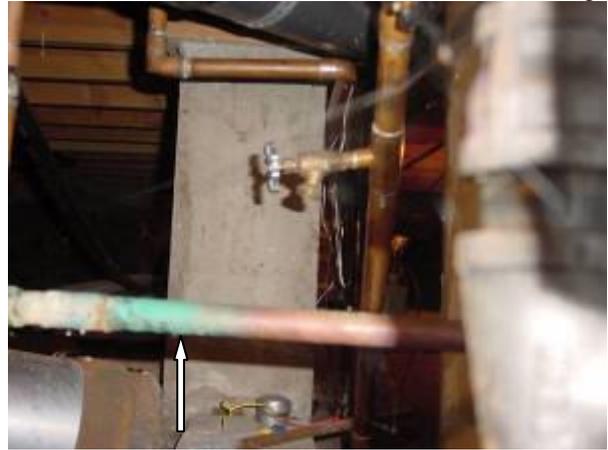
- **Monitor:** Corrosion on the exterior of the supply piping was observed in several locations of the crawl space. It is recommended to monitor these areas for leaks.

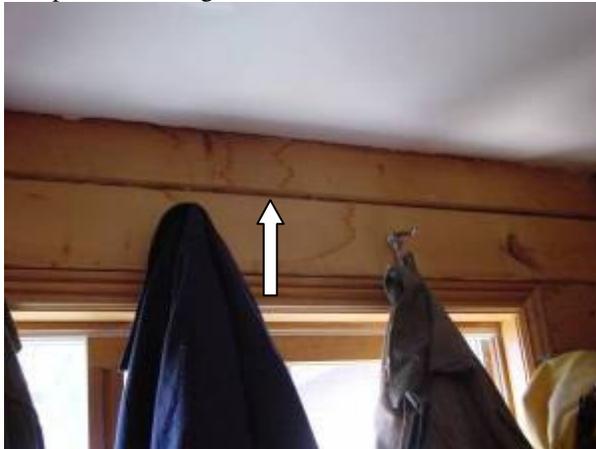
- **Monitor:** Water staining was noted in the rear entrance along the ceiling of the East wall. This could be due to past or present leaking.

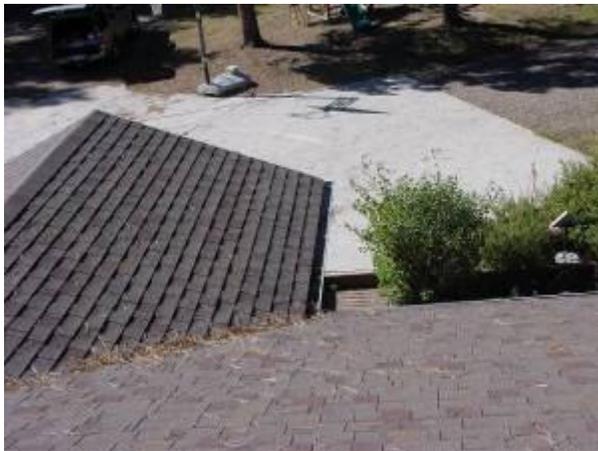
- **Major:** The roofing is near the end of its life. Watch for leaks and expect to replace the roof soon.

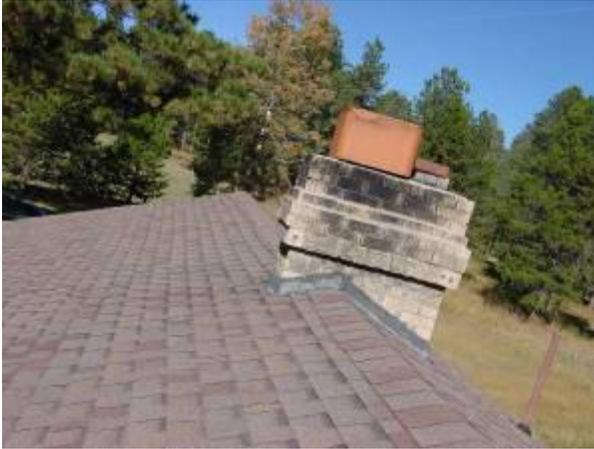
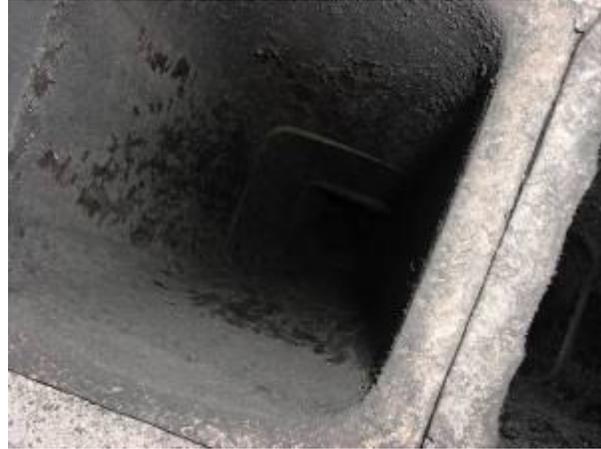
- **Improve:** A rain cap and vermin screen installed on the masonry chimney would reduce the risk of vermin making a nest and also reduces the risk of forest fire caused by blowing embers.

- **Repair, Safety Issue:** The masonry chimney should be cleaned to help assure safe, effective operation.

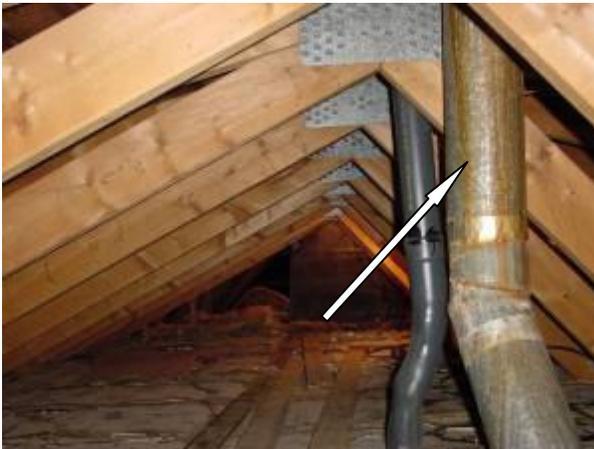
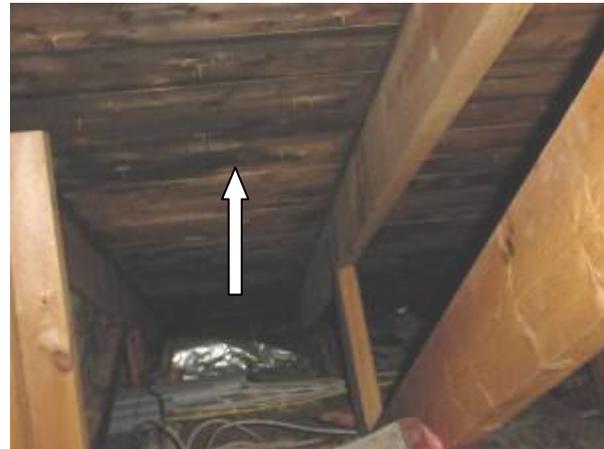
- **Maintain:** The gutters require cleaning to avoid spilling roof runoff around the building – a potential source of water entry or water damage.
- **Repair:** There is evidence of past or current leaking in the attic at the boiler exhaust vent penetration.
- **Repair:** The underside of the roof also shows signs of past or current moisture and possible leaking.
