Building Inspection Report

1842 Somewhere Drive

Inspection Date:
10/01/2005

Report Number:
78905

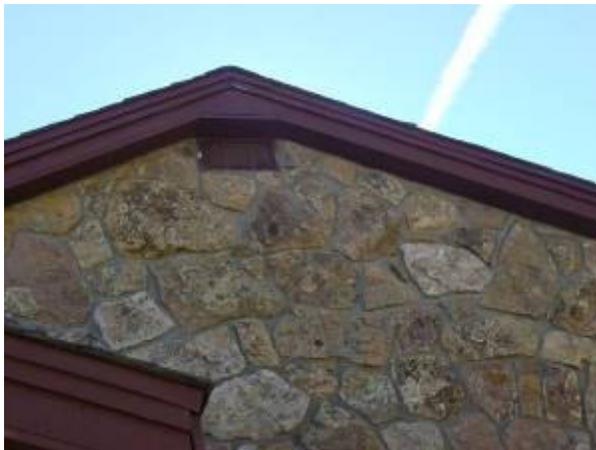
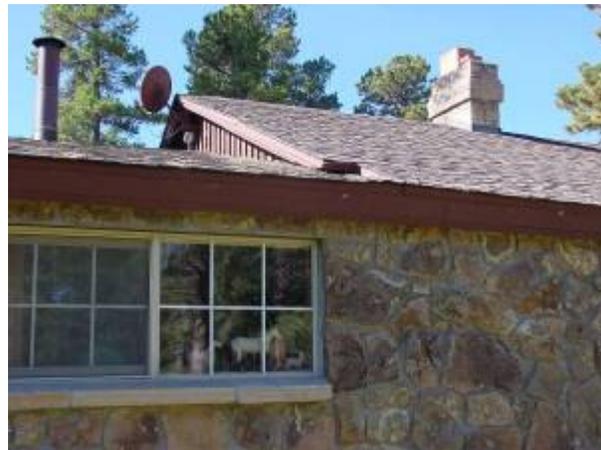
French drains are present to facilitate better drainage.

The stone work on the exterior walls of this home is of exceptionally high quality.
